## Swiss Re Club House, Zurich\*

### Artificial Nature

\* A project by Kienast Vogt Partners

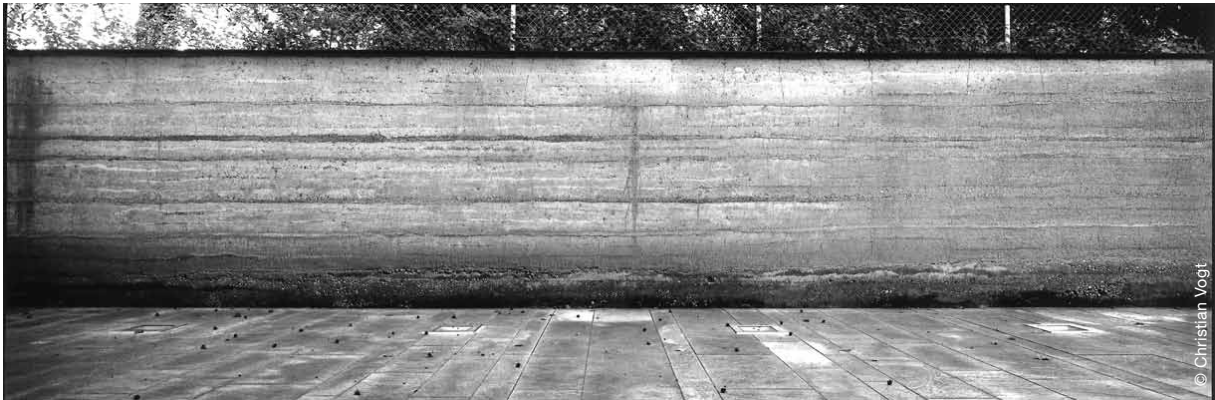
A wall made of rammed clay recalls a section cut into the soil showing various soil horizons and creating a colourful picture whose intensity varies with the weather. The fascinating mass of rammed clay and the pleasant climate it helps generate are quite noticeable on the terrace

On the cafeteria terrace, a wall made of rammed clay evokes the picture of a cut in the earth – the colourful ribbons of different layers of soil – with the intensity

of the hues varying according to the weather. The fascinating mass of rammed clay and the pleasantly cool climate it generates are quite noticeable on the terrace.
